## FM & DAB+ transmitters of the SWR now in operation Acceptance measurement at the SWR location "Hochblauen"

by: Viktor Mann, KATHREIN Broadcast GmbH, Rohrdorf, 29th May 2020

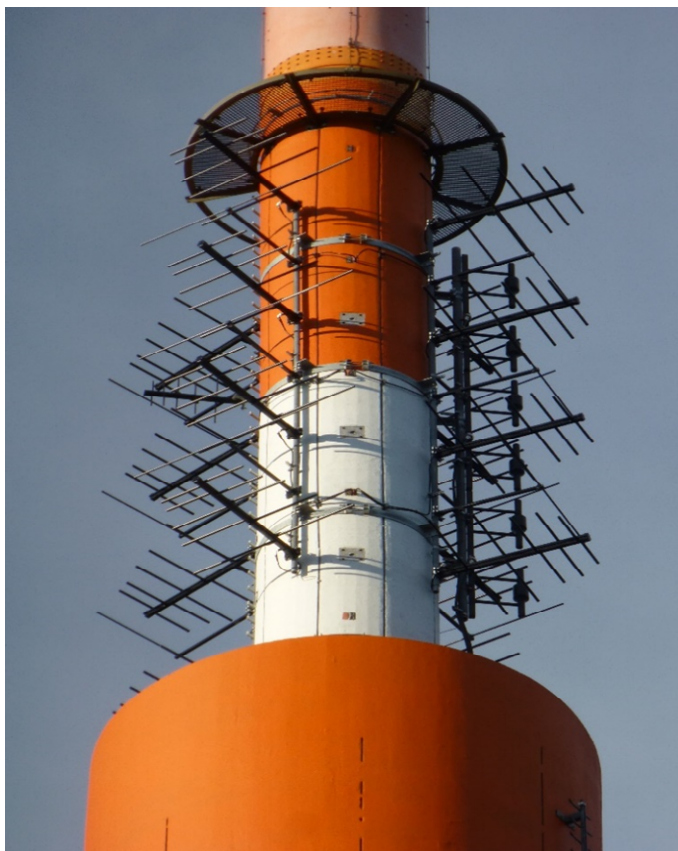
Left picture:  
FM transmission antenna with integrated vertical DAB dipoles

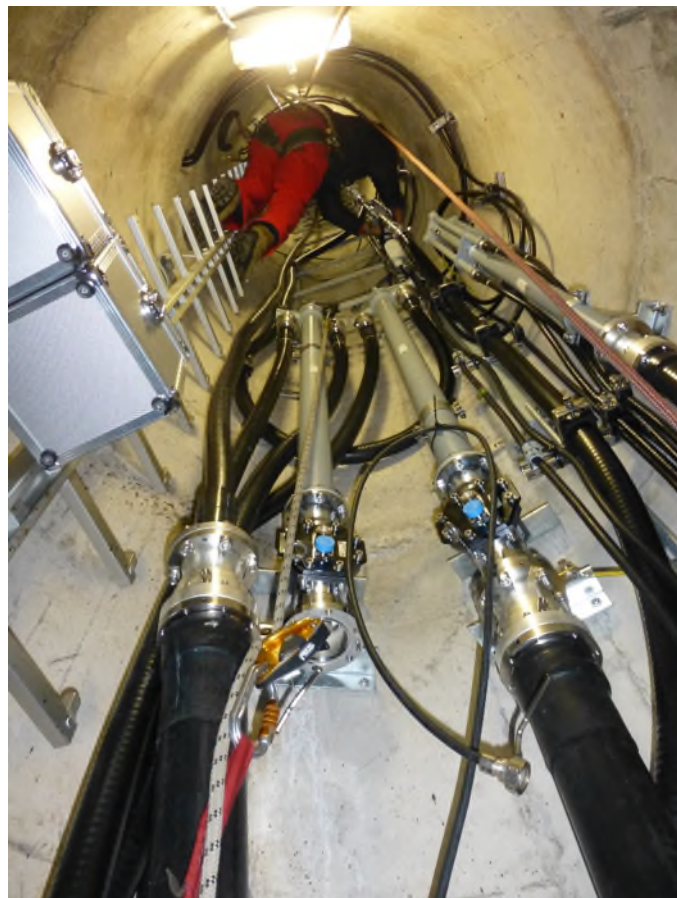
Finally, the "knock test" is carried out. The components of the antenna system are lightly pushed with a fist or a small rubber hammer. At the same time, a colleague in the transmitter room observes the measurement curve on the connected pulse reflectometer. If this remains stable, everything is fine. If there are jumps in the measurement curve in time with the knock, this usually indicates a loose connection. This must then e.g. be lifted by tightening. With the high transmitter powers that are common in broadcasting, poor connections could lead to fires in the system.

*Picture above:  
Inside the transmission tower, the "knock test"*
